# ST THOMAS ANGLICAN CHURCH CONSERVATION MANAGEMENT PLAN

Port Macquarie | NSW  
Issued March 2024 | Final (Amended)

### **St Thomas Anglican Church, Conservation Management Plan**

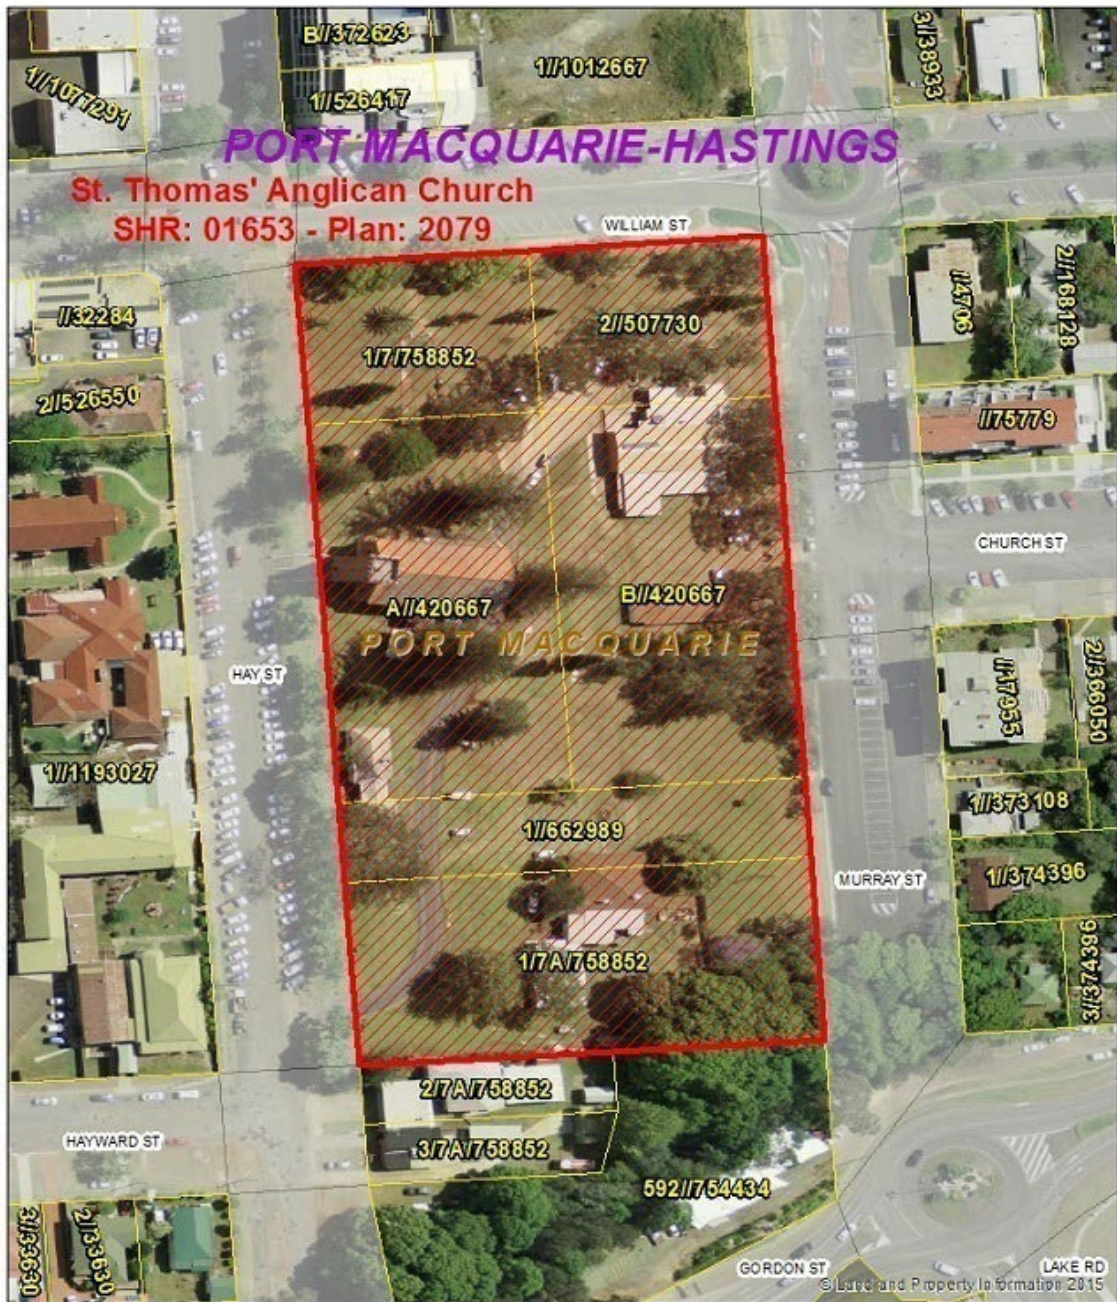
State Heritage Register - SHR 01653, Plan 2079  
 St. Thomas' Anglican Church  
 Hay Street, Port Macquarie

The St Thomas' Anglican Church, and as identified in the listing as including, its site and associated buildings, is included on the NSW State Heritage Register as item no. 01653 and listed on 18 October 2002.

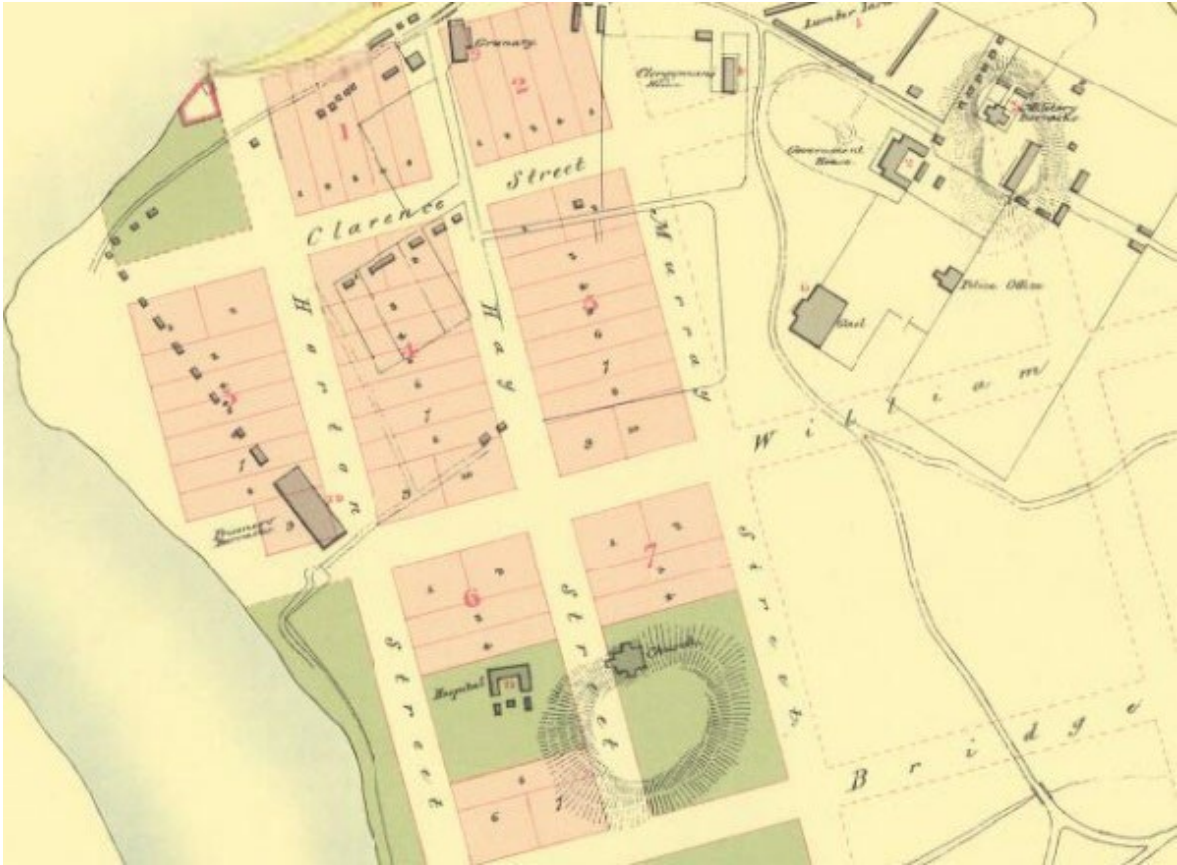
Figure 8 This map shows the location of the church on the side of a roughly circular hill. A more regular street alignment has been imposed over the earlier penal settlement buildings, April 1831. Source NLA 3640111-1804673252-map.

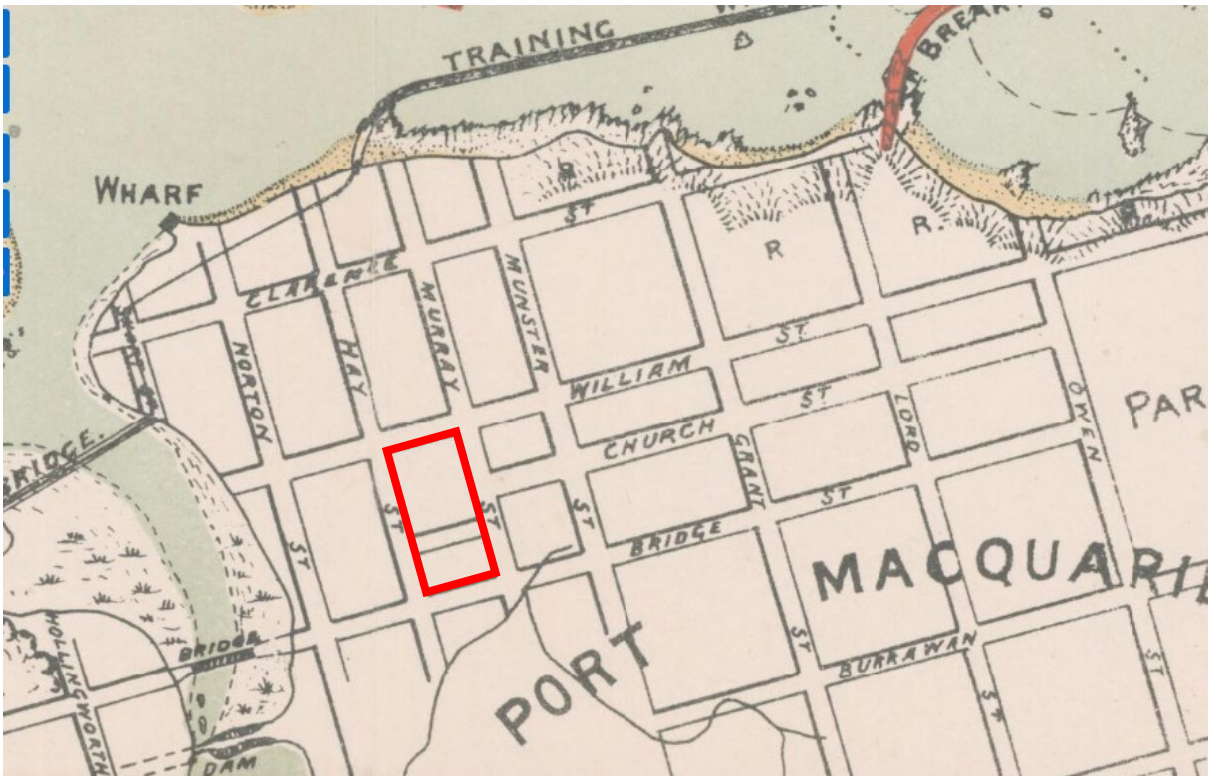
Figure 9 New South Wales harbours: Hastings River entrance showing church block (outlined in red) with road way 1902. Source: New South Wales harbours: Hastings River entrance. (nla.gov.au)

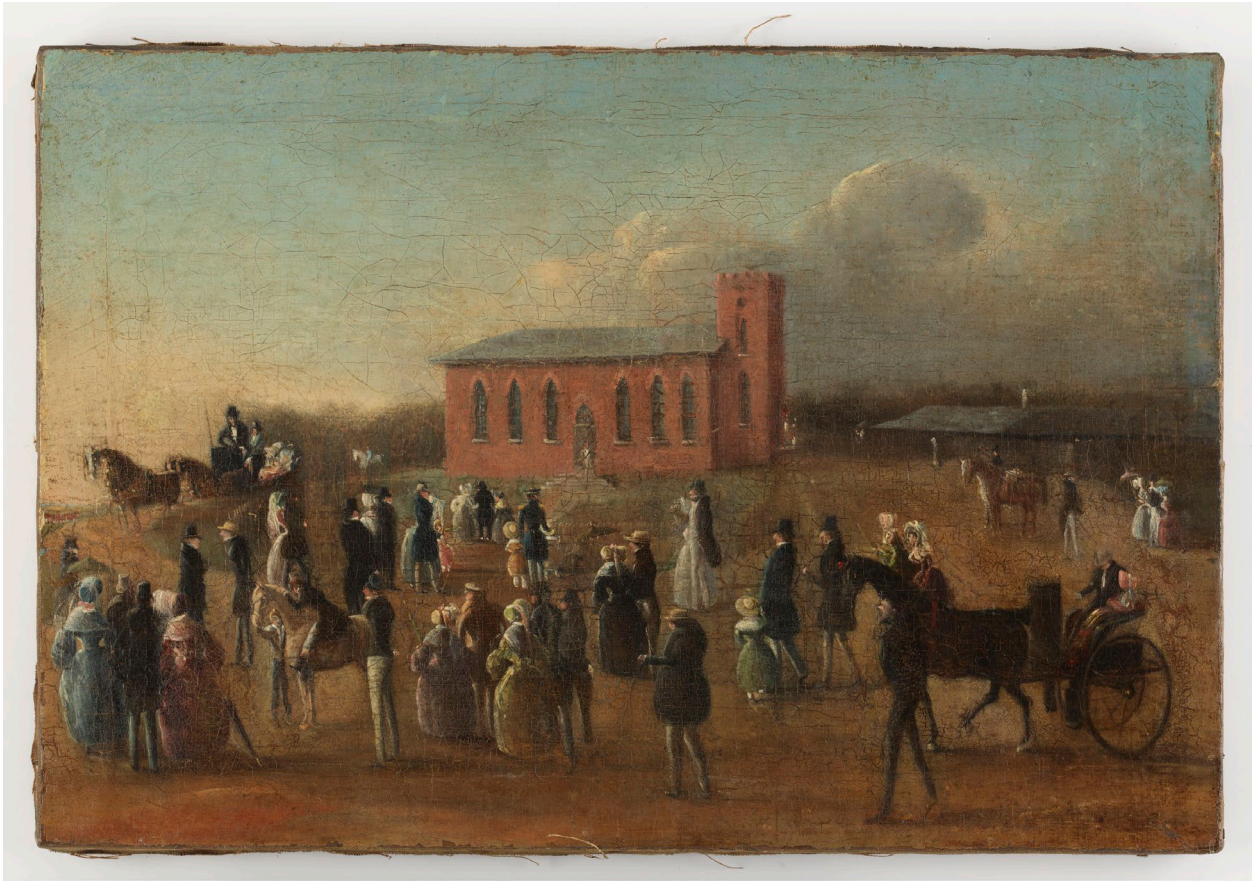
Figure 12 St. Thomas' Church, Port Macquarie, 1833-1842 by Joseph Backler. This image shows officers of the Red Coats leaving the church building, indicating that this image is most likely set before 1838. The building on the right is mostly likely the hospital building, and before the road was redirected. Source: ML 273

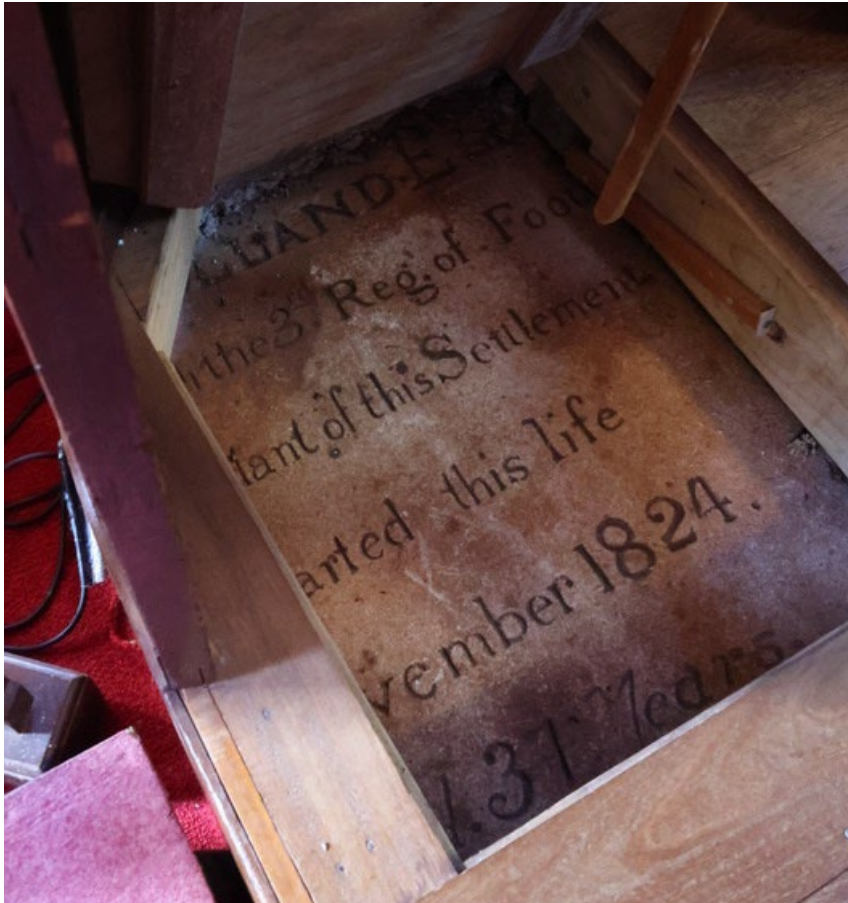
Figure 13 Captain Rolland's gravestone. Source: Author, 2022.

The Commandant was subsequently buried in the precincts of the church to be, and his gravestone is to be found in the nave under the southeast box pew.

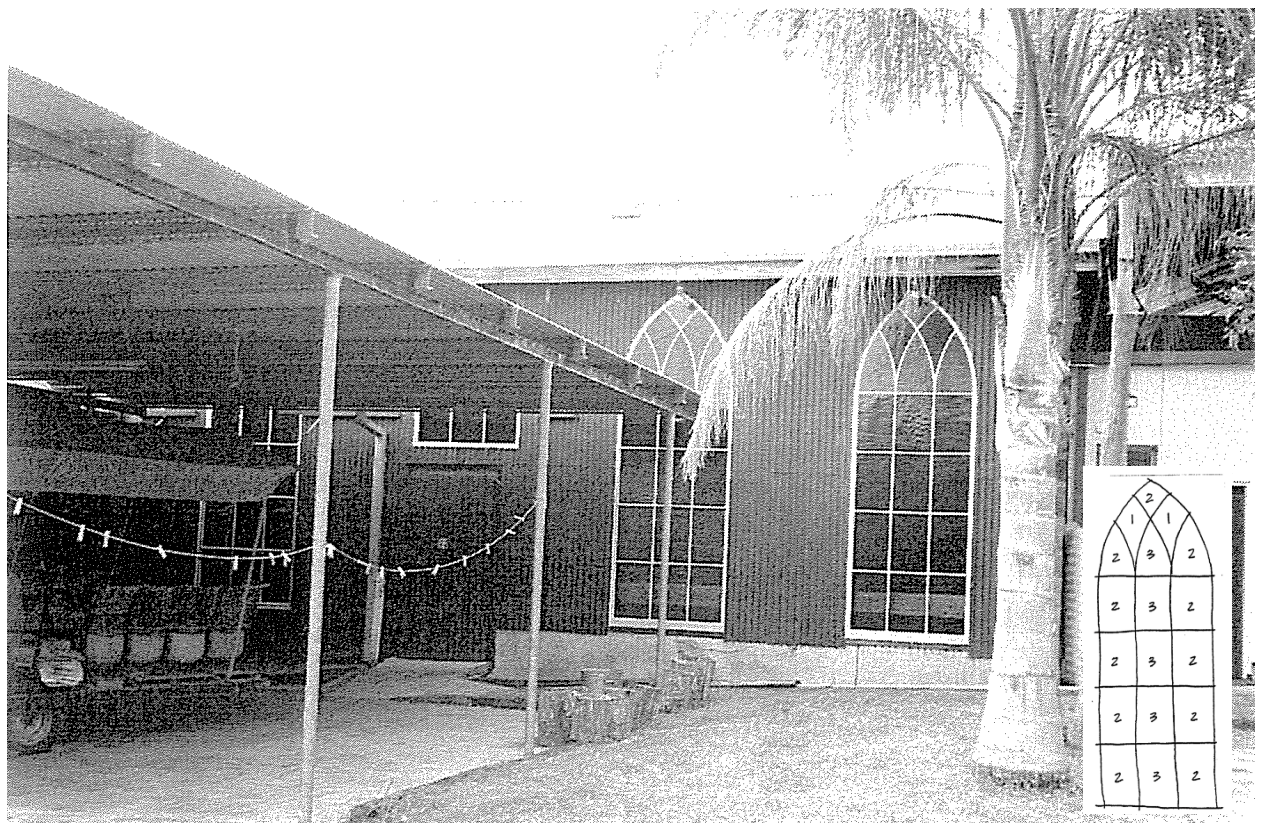
Figure 17 Former St Thomas' lancet windows in place at The Old Butter Factory Telegraph Point, NSW. Sketch of windows existing in The Old Butter Factory, indicating colour: 1 – ruby red, 2 – blue, 3 – amber. Source: Suters Architects.

Between 1897 and 1978, the windows were of a simpler, yet similar design - a 12-pane lower section with a 6-pane lancet arched head. The glazing in these windows was in a design of blue, amber and ruby red. It appears, from photographs, that the upper three rectangular panes of these windows pivoted horizontally to allow ventilation. With the installation of the present windows in 1978, the tri-colour windows were sold, four of which exist as part of the structure of the Old Butter Factory at Telegraph Point, just north of Port Macquarie. The photograph below (figure 8) shows these windows in place in the Butter Factory as they presently exist. The fate of the remaining tri-colour windows is unknown.

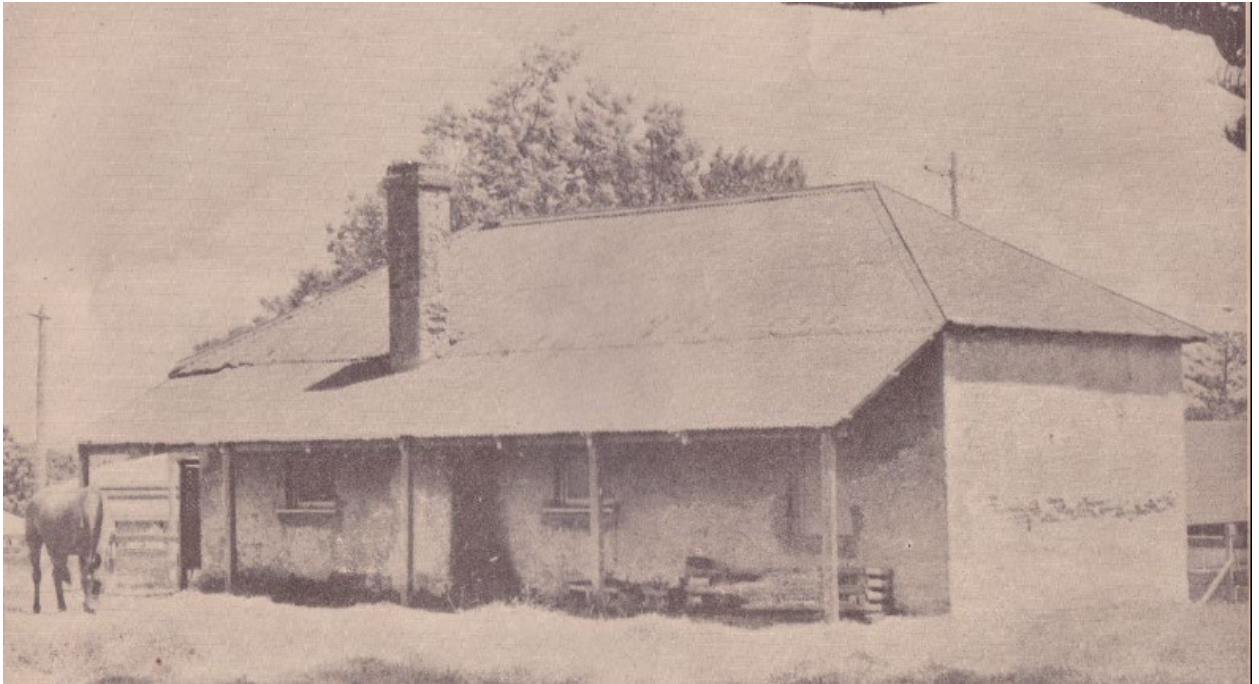
*Figure 24 Photo taken c1850s showing the old dispensary which was converted into two classrooms for the Parochial School. Source: St Thomas' Church Archives.*

The Dispensary was used as a Parish School from 1847 until the Port Macquarie Public School was established in 1867. The building was again used as a Pre-School Kindergarten from 1950 until the new Parish Hall was opened in 1961.

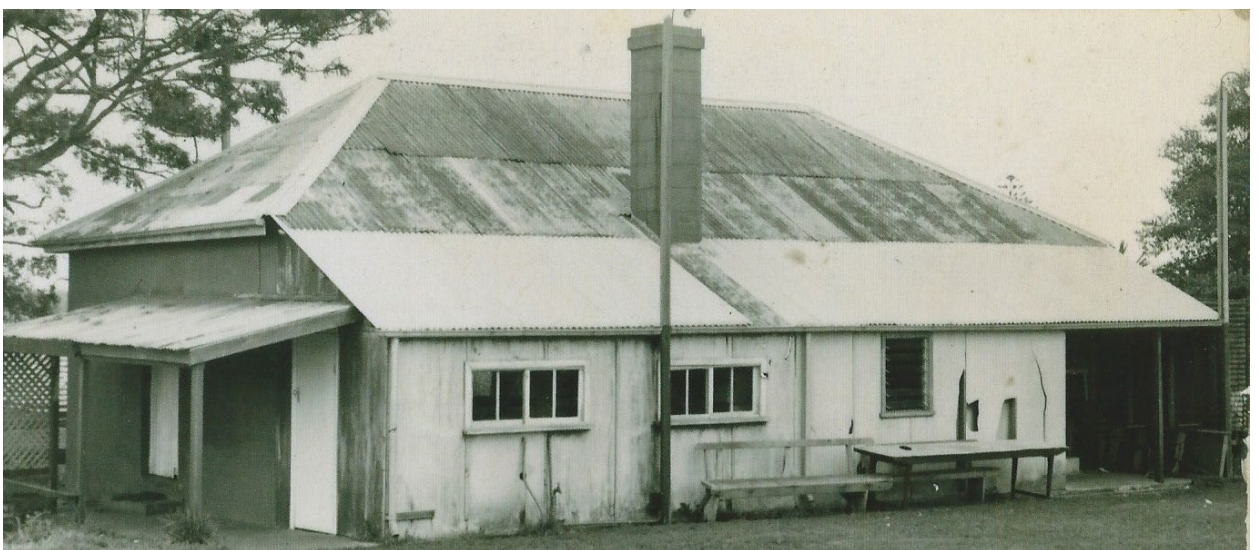
*Figure 25 Photo taken in 1950 of the old school room (previously the surgeon's dispensary) which was also used as a Church Hall and a pre-school kindergarten. The new hall was built in 1961 and this building was transformed into a Chapel in 1966. Source: St Thomas' Archives.*

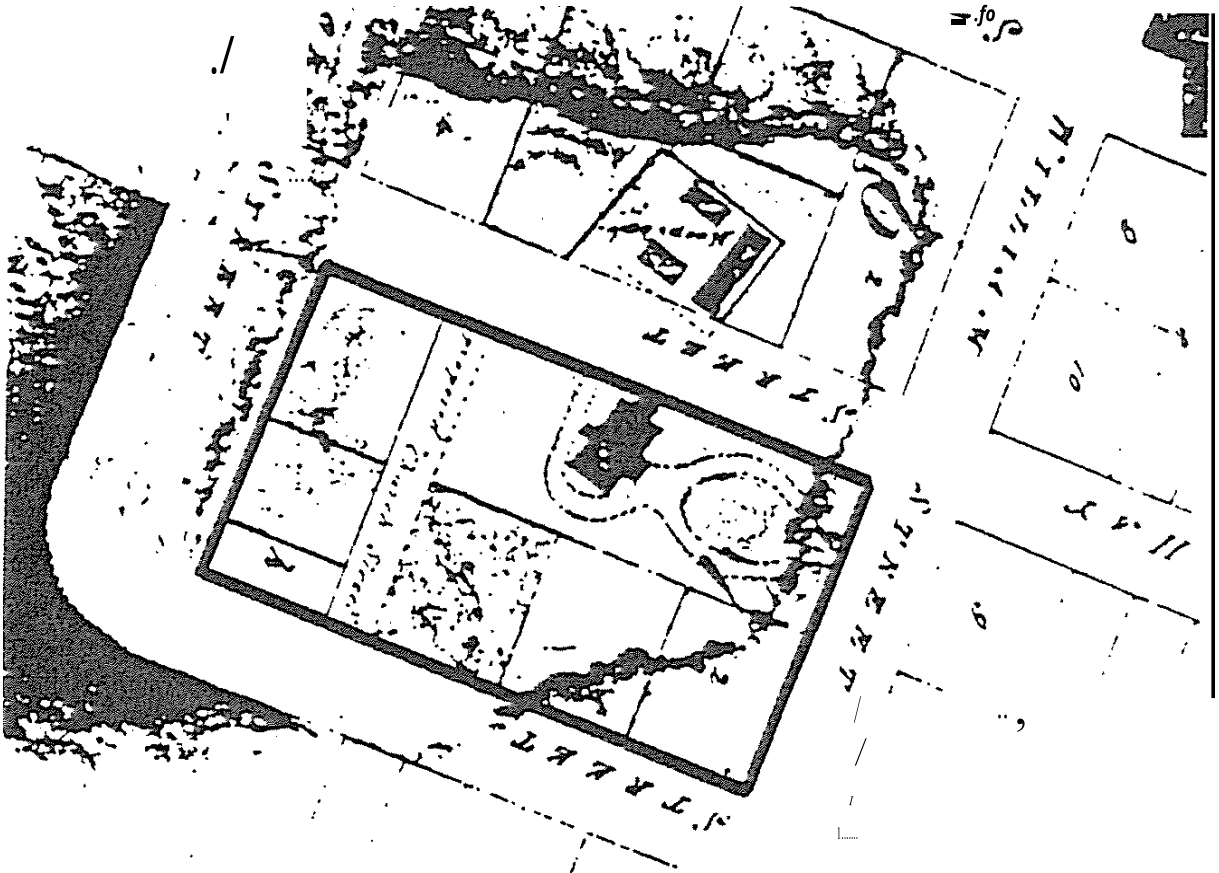
Figure 27 Portion of c1834 Port Macquarie town map, showing layout of access roads within the grounds of St Thomas'.  
Source: David Boram and Associates.

Formerly a part of the hard landscaping was a large 'garden wall' which was "as high as the walls and had two arched doorways or openings. The intention of this screen was to shield from public and curious gaze, the awkward descent of women, encumbered by their large crinoline skirts, as they alighted from their carriages." This can be seen on the northern side of the church, at the end of the carriage loop, in Figure 27.<sup>31</sup>

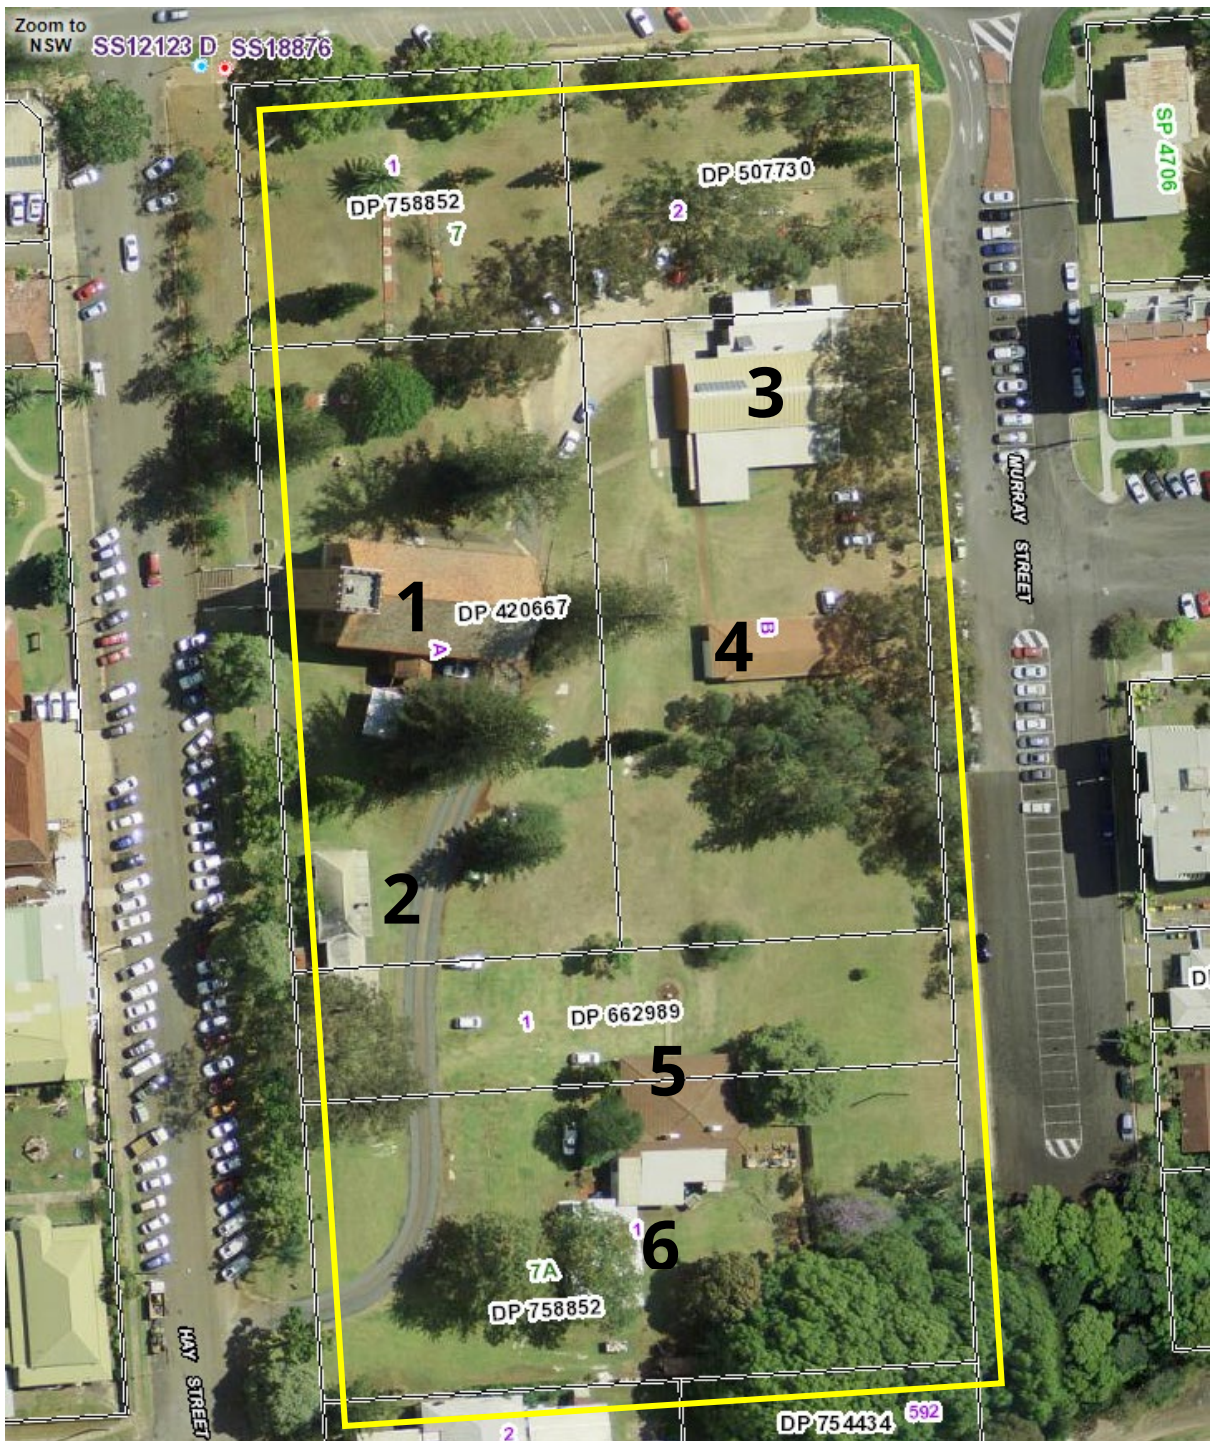
Figure 37 Image showing LEP heritage listed boundary in yellow (SixMaps)

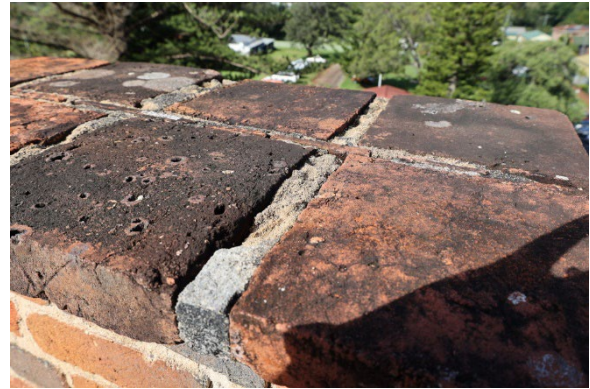
Figure 42 Detail of brickwork condition in tower. Source: Author

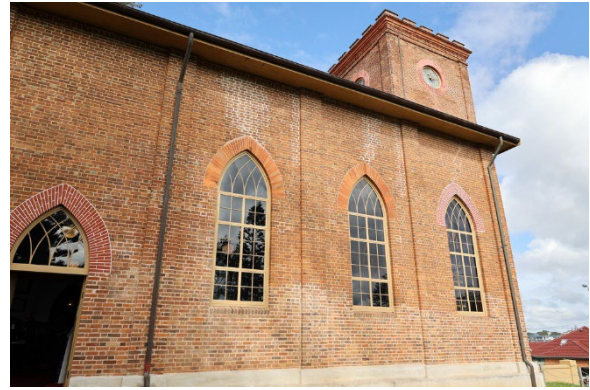
Figure 45 View of windows on north elevation. Source: Author

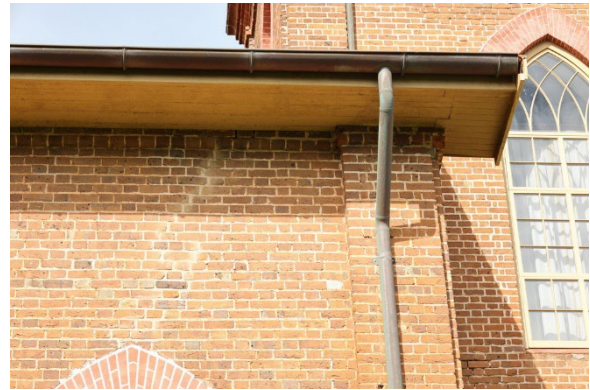
Figure 47 Detail of brickwork condition on north elevation. Source: Author

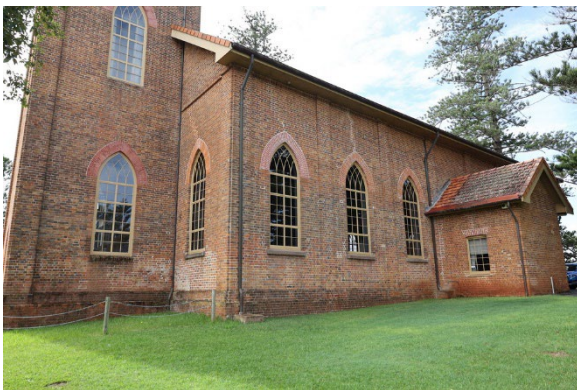
The vestry, on the southern side of the church, is accessed by a single timber framed door on its eastern elevation. It has a 12-pane double-hung sash window in its western elevation. Unlike the other openings, the door and window in the vestry are set within flat-arched openings. The southern elevation of the church has a lime rendered plinth however this is not evident on the vestry.

Figure 52 View of south elevation. Source: Author

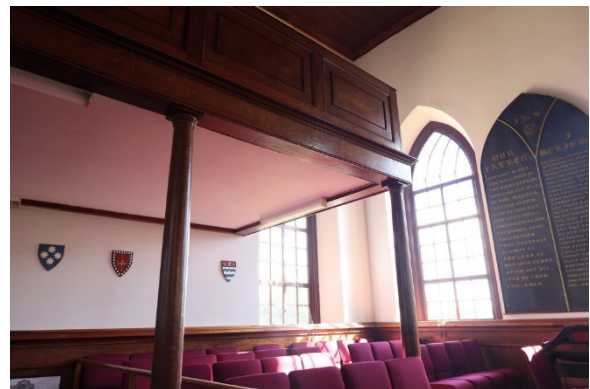
A single cedar-panelled door in a square opening leads from the foyer to the nave. The gallery above, housing the pipe organ and a few pews acts as a portico over the entrance. It is supported by four timber columns and has a relatively unadorned cedar-panelled balustrade. To each side of the aisle under the gallery is a raised plinth containing pews.

Figure 59 View of organ gallery from nave. Source: Author

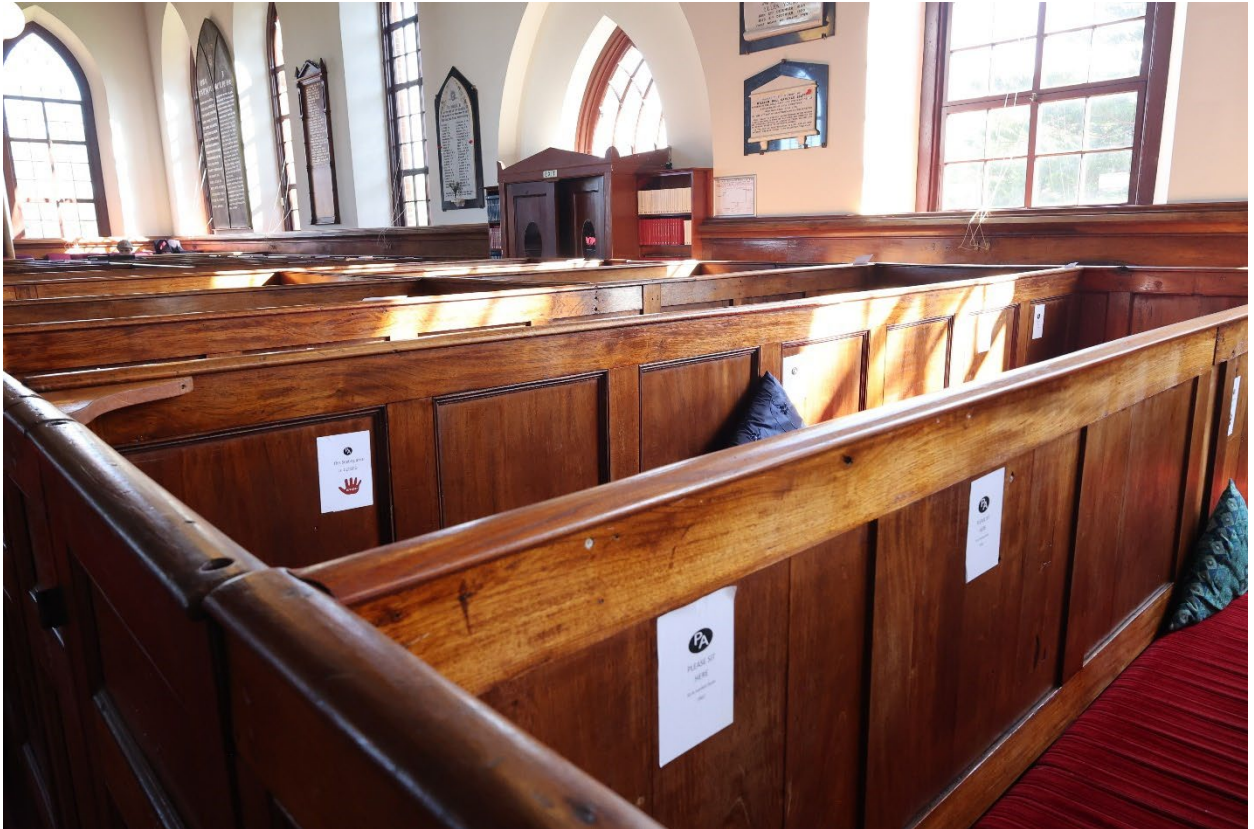
Figure 65 Restored pews. Source: Author.

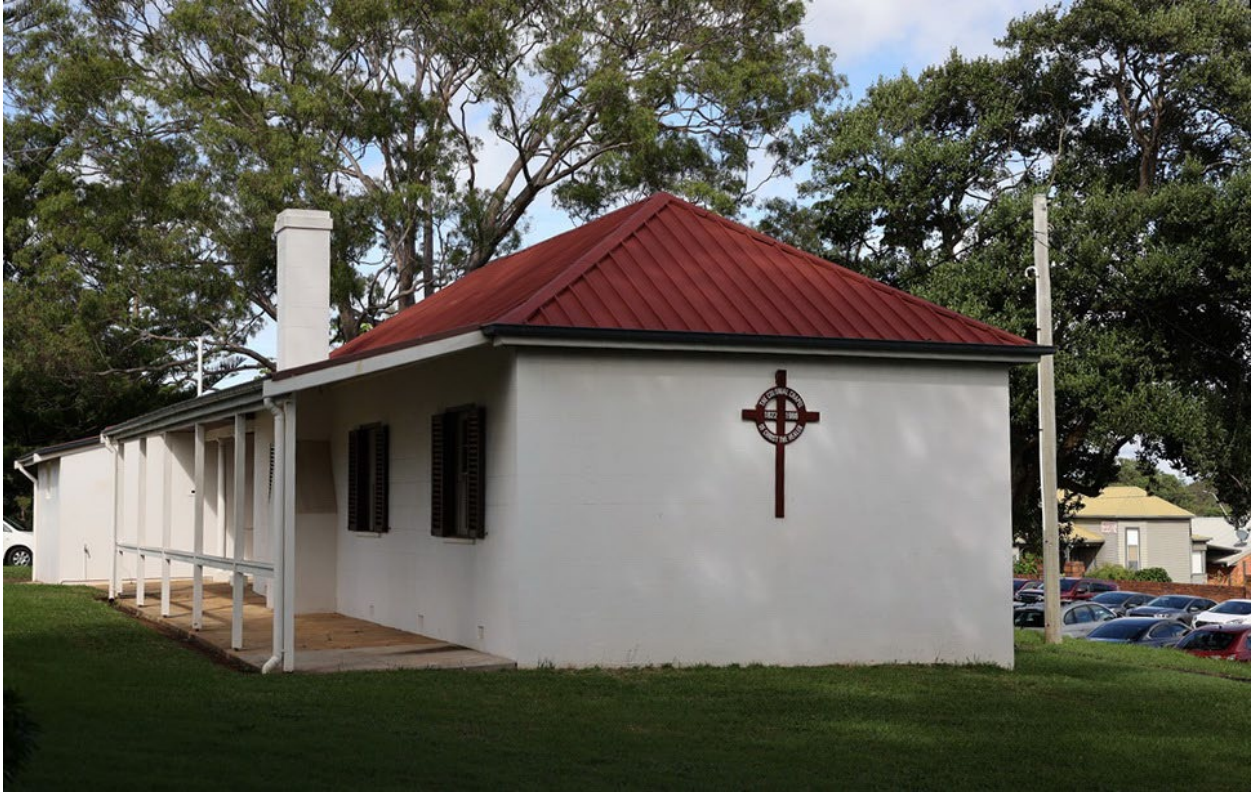
Figure 66 The Chapel as it is viewed today. Source: Author

The earlier building has nine-pane double-hung timber sash windows set into openings with external timber louvred shutters and slim stone sills. There is evidence of severe decay in some of the timber windowsills and frames. There is evidence of numerous paint coatings external with earlier coats failing due to moisture within the substrate.

The verandahs have square timber posts and simple handrails whilst the breezeway has slim circular columns with Tuscan capitals on a square concrete base. A concrete breeze-block nib wall screens the entrance to the outbuilding from the street.

The Chapel has been significantly modified since its construction as a dispensary for the Colonial Hospital such that its original use and functioning cannot be understood. It has functioned as a schoolhouse, vestry and administration building prior to its conversion to a chapel in 1965. It is in good condition and externally, the building form of the northern building and much of its fabric convey the values associated with it being a convict-built structure and a building that is valued by the church community.

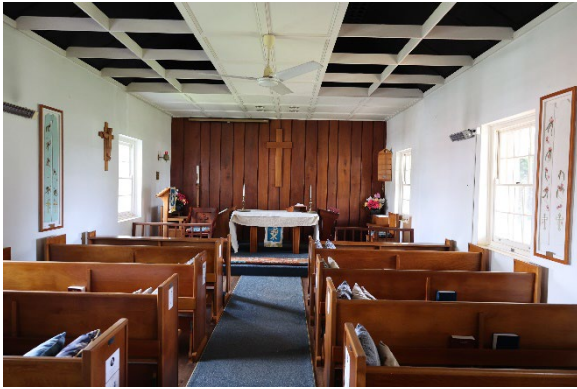
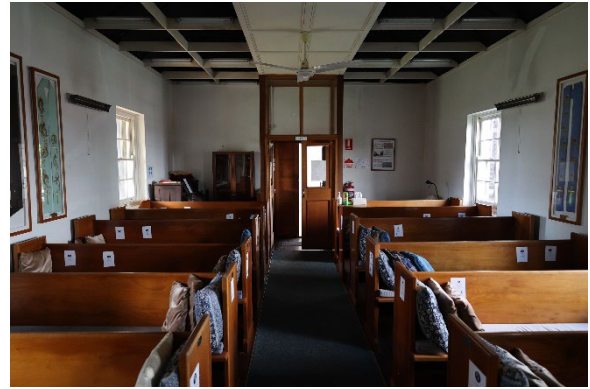
The interior of the former dispensary is one large space with a central aisle flanked by timber pews. The entrance door at the southern end has an internal wind lobby of timber and glass panelling. The ceiling is lined on the rake above a central panelled ceiling with an open grid to either side. The floor is carpeted over timber boards and the walls and plastered and painted.

Figure 34 View of chapel interior. Source: Author

Figure 34 View of chapel interior looking towards door. Source: Author

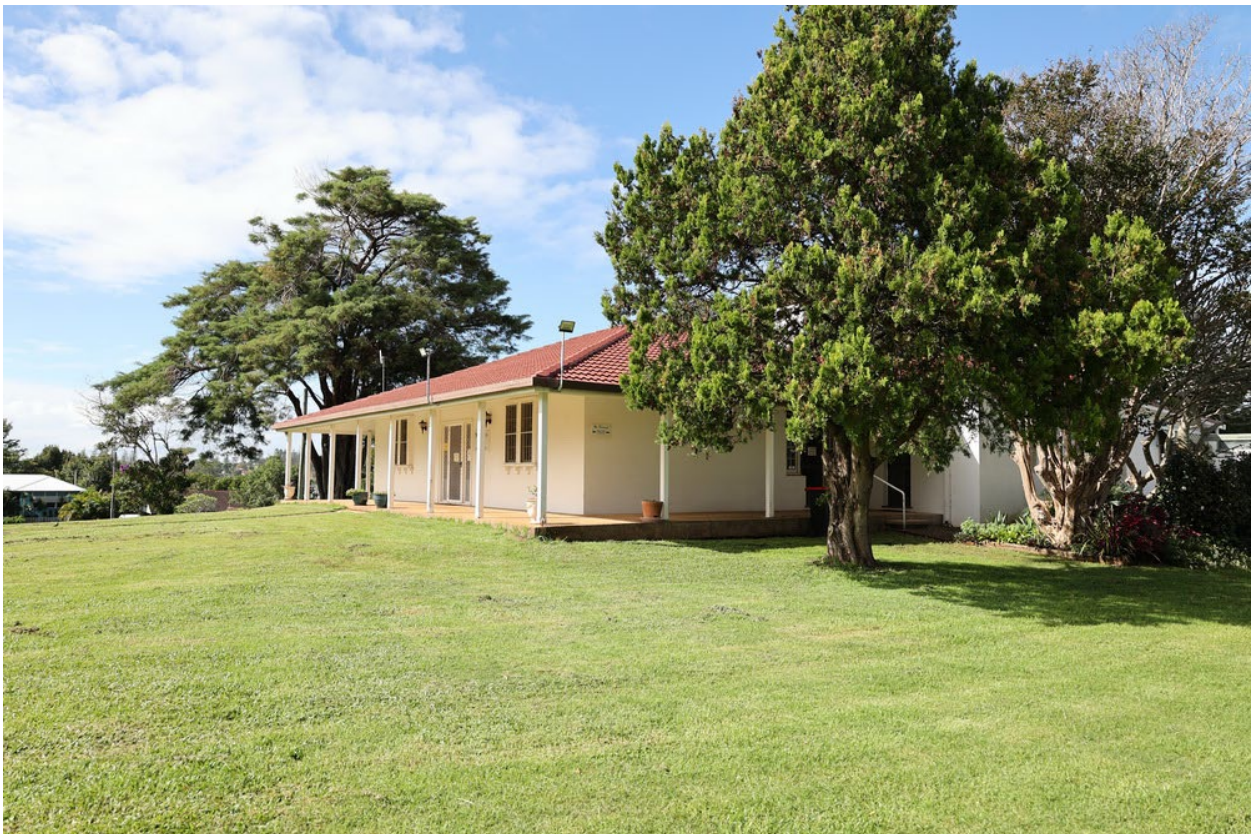
The former Parsonage faces north from high ground at the southern end of the church site. It is a rectangular building with additions to the southwest corner. The earlier building has ruled ashlar walls with a hipped roof of Tuscan-styled tiles. It is bound by concrete floored verandahs on three sides which are held under the main roof and supported on plain timber columns. The entry door is in the centre of the north elevation with a window to either side. The windows protrude from the façade on brick corbels under a timber sill and frame containing two tall and thin double-hung sash windows.

Figure 67 View of former rectory. Source: Author

Constructed in 1937/8, the Administration Building is in good condition for its age and type of construction. Noting it was constructed as a new parsonage to replace the earlier adaptation of the former Colonial Surgeon's Residence, records indicate that portions of the original front wall were retained in the 1920s construction however any evidence has been concealed and is not demonstrable on examination of the building fabric. The original cellar and well (1822) provides a tangible link to its colonial heritage.

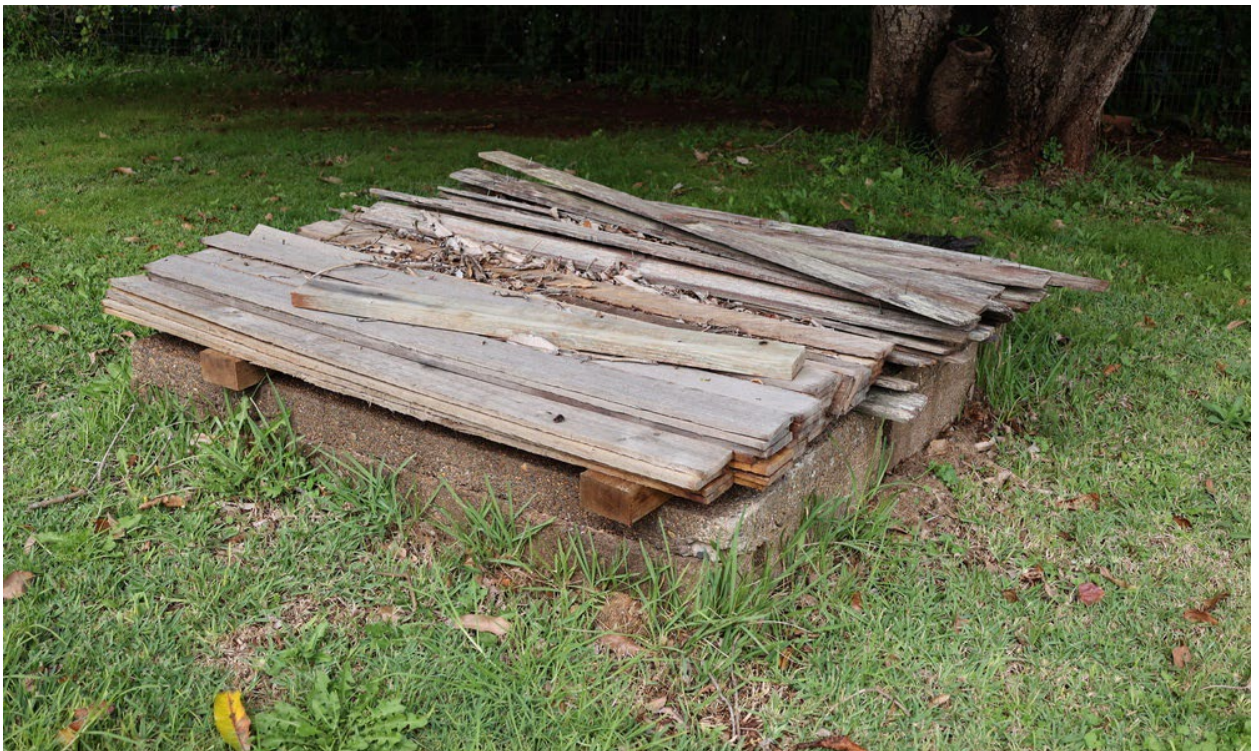
A timber paling fence encloses a rear yard which contains a timber pergola. It also contains building materials including a stockpile of convict-made bricks, and a well that has been covered.

Figure 69 Location of former well at the rear of residence. Source: Author

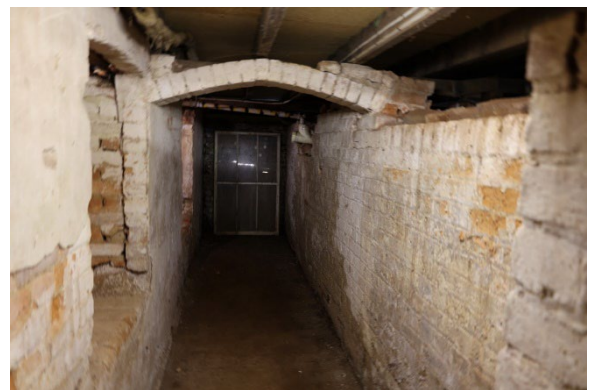
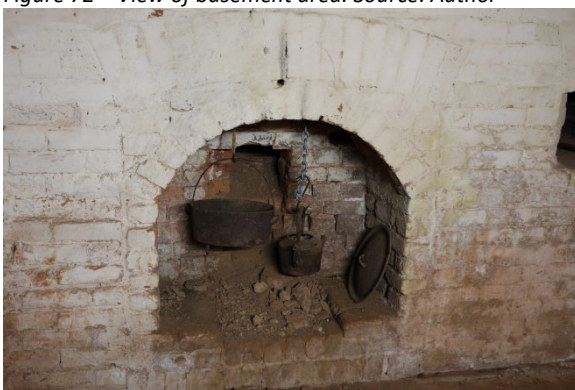
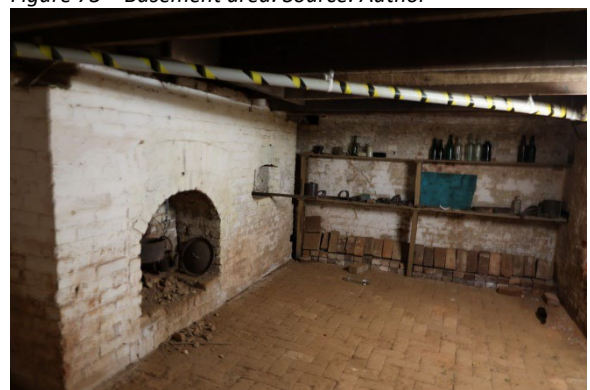
The cellar demonstrates the building fabric of the earlier Colonial Surgeon's Residence and consists of lime-painted face brickwork. The floors are concrete, or brick paving and brick arches and fireplaces provide evidence of its former use. The building is used as offices and the Op Shop is contained within the garage.

Figure 73 Basement area. Source: Author

Figure 74 View of basement area. Source: Author

Figure 75 Basement area. Source: Author

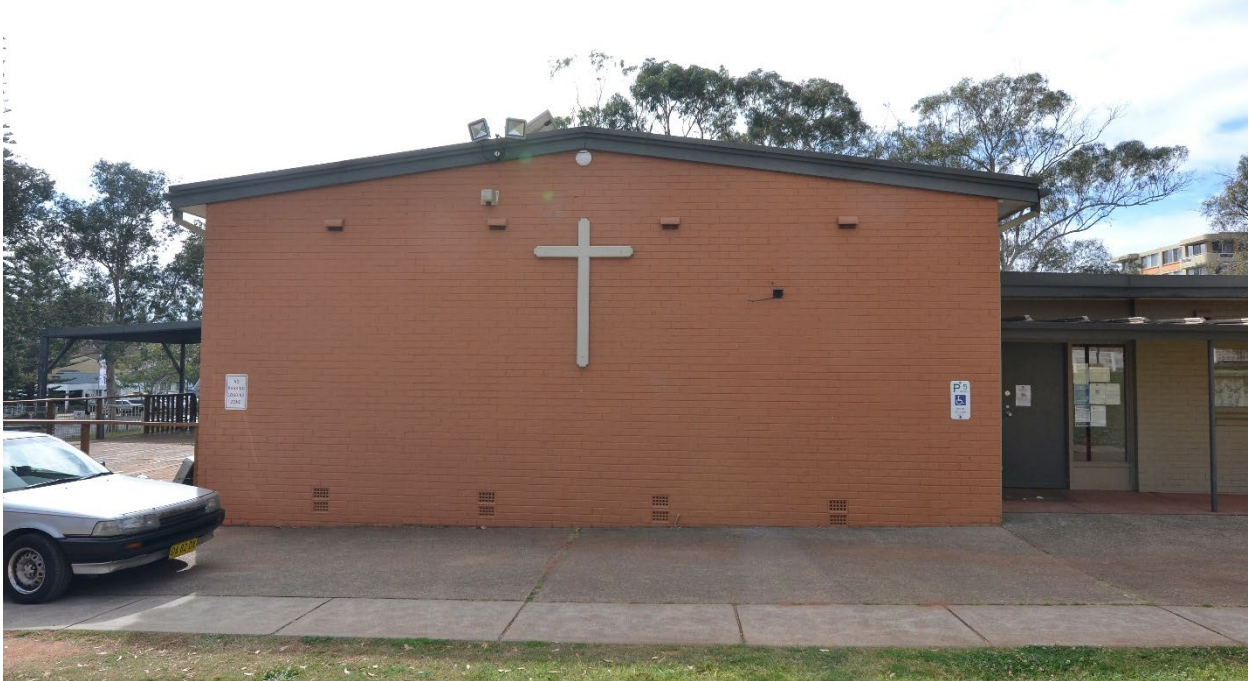
The Parish Hall is a painted brick building consisting of the main hall with a low-pitched gable roof running east to west surrounded by lower flat-roofed buildings to its north, south and east containing the entry, kitchen, and amenities. The building has metal deck roofs with timber fascia.

Figure 76 View of Parish Hall. Source: St Thomas' Archives

Constructed in 1961, the Parish Hall is in fair condition for its age and construction. It has been well used by the community and has undergone minor changes to suit changing requirements. It continues to support community and parish activities.

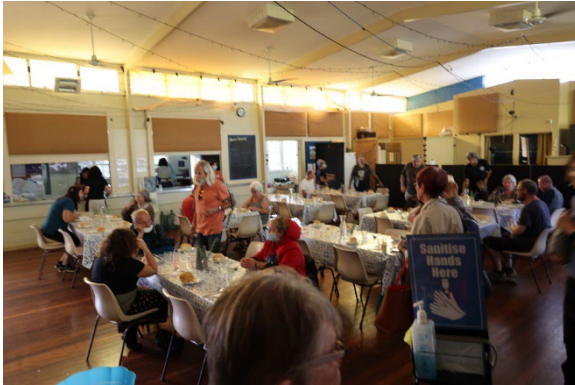
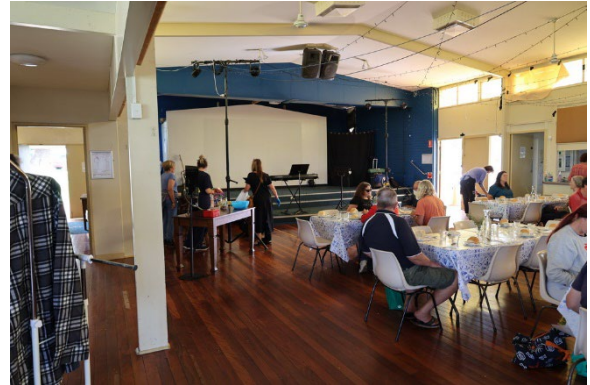
Internally the hall is an exposed portal-framed structure with a ceiling lined on the rake. It has a timber floor and painted brick or dry-clad walls. Windows are located under the eaves line in the main hall area and there is a stage at the western end.

Figure 78 View of the interior of the hall. Source: Author

Figure 79 View of the interior of the hall. Source: Author

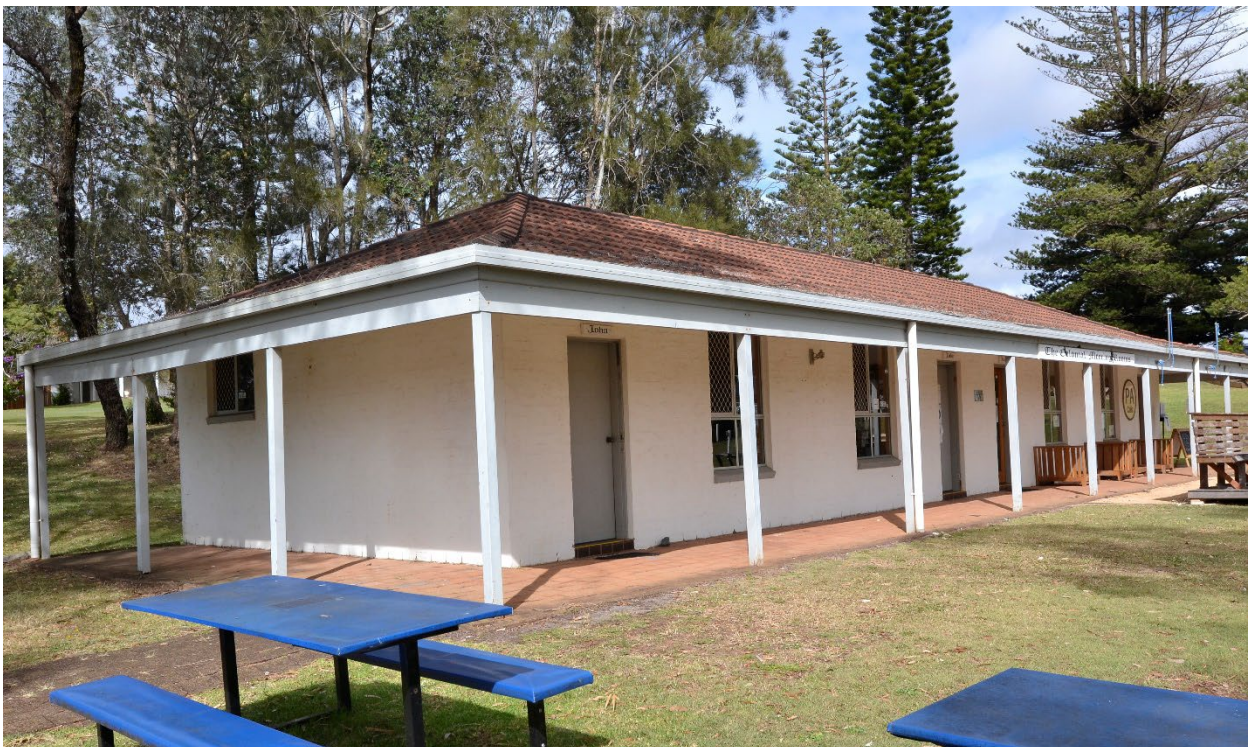
The long rectangular building called the Colonial Meeting Rooms faces north towards a grassed courtyard between it and the Parish Hall. It has a hipped roof with a verandah along its northern face contained under a broken pitch.

Figure 80 View of Colonial Meeting Rooms (modern). Source: St Thomas' Archives

Constructed in 1987, the Colonial Meeting Rooms are in good condition and continue to provide amenities to support church and community activities. It has undergone little change since construction.

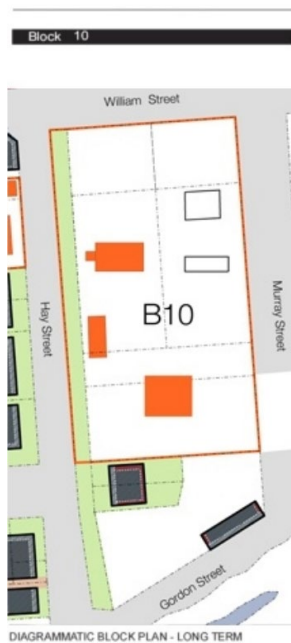
Figure 90 Extract of Plan and Table showing Port Macquarie Town Centre, Block 10 controls.

St Thomas Church Group is located in Block B10. St Thomas Church, the Chapel of Christ the Healer and the Administration building are noted as heritage buildings. Soft landscaping with deep soil is provided for in a strip to the Hay Street frontage of the land.

Block 10			
Control	Ground	First	Second and above
Maximum Building Depth	20m maximum	20m maximum	N/a
Front Boundary Setback			
Hay Street	Minimum 10m	Minimum 10m	N/a
Gordon Street	Minimum 0m	Minimum 0m	N/a
Rear Boundary Setback	Minimum 12m	Minimum 12m	N/a
Western Lots	Minimum 0m	Minimum 0m	N/a
South Lot			
Side Boundary Setback	Minimum 3m	Minimum 3m	N/a
Western Lots	Minimum 0m	Minimum 0m	N/a
South Lots			
Façade Enclosure	Flexible	Flexible	N/a
Front Articulation			
Zone	Minimum 1.8m	Minimum 1.8m	Minimum 1.8m
Western lots	Maximum 4m	Maximum 4m	Maximum 4m
South Lot	0m	Minimum 1m	Minimum 1m
		Maximum 3m	Maximum 3m
Rear/Side Articulation	Location on Plan		
Awnings	N/a		
Pedestrian Entry	From streets		
Vehicle Entry	Off Hay Street and Gordon Street		
New Streets, Laneways and Paths			
Arcades	N/a		
Car Parking	Underground, on street, some on grade		
Landscaping			
Soft	Location on Plan		
Hard
